Loss of Signal

Aeromedical Lessons Learned from the STS-107 Columbia Space Shuttle Mishap

Executive Editor
Philip C. Stepaniak

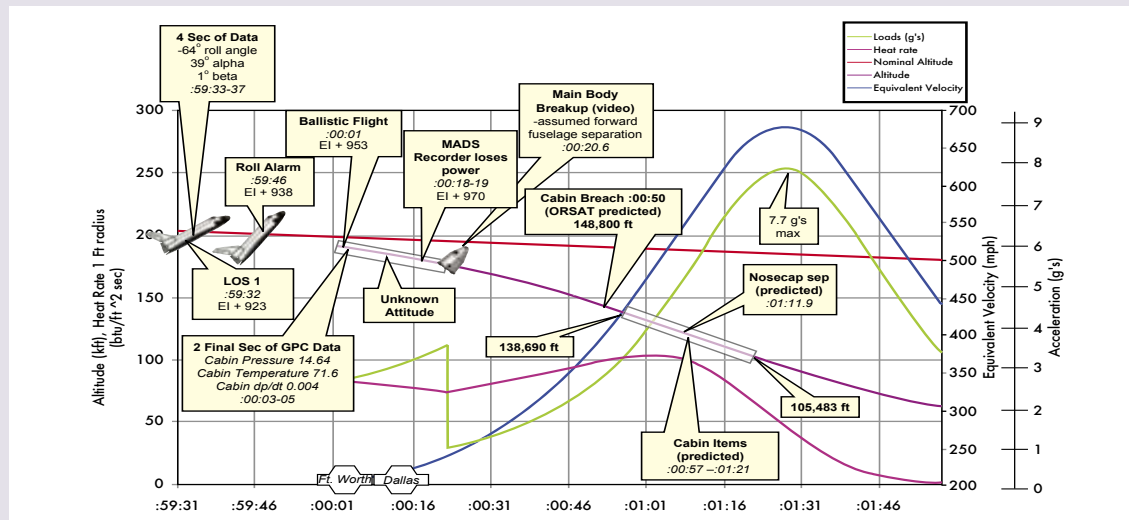
The CSWG provided this timeline, which shows where the module failure and decompression started. This timeline was slightly revised in future investigations and more details were published with the *Columbia Crew Survival Investigation Report, 2008*. The forensic evaluation of all recovered crew module and forward fuselage components did not show any evidence of over-pressure or explosion. This conclusion was supported by both the lack of forensic evidence and a credible source for either sort of event. The failure of the crew module resulted from the thermal degradation of structural properties, which resulted in a rapid, catastrophic sequential structural breakdown rather than an instantaneous "explosive" failure.

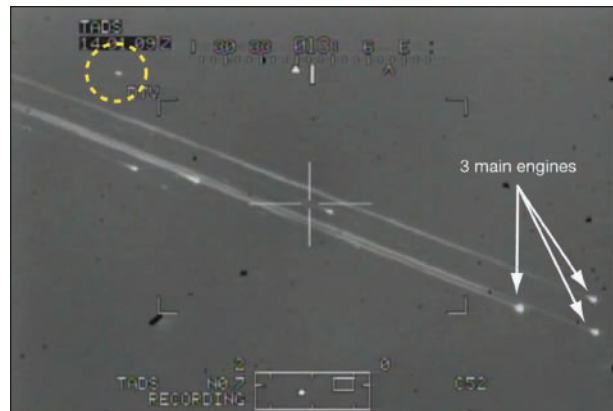
Image is from the Apache video. Dotted circle indicates area where the crew module debris was last visible. The three points in the lower right are the orbiter's three main engines. The forward fuselage and crew module fragmented into pieces quickly and became too small to detect by ground-based video. At approximately GMT 14:35:00, the crew remains and the majority of the crew module debris completed the free fall to the ground.
